221 Mount Auburn Street Riverview Condominiums

Community Meeting

July 10, 2025

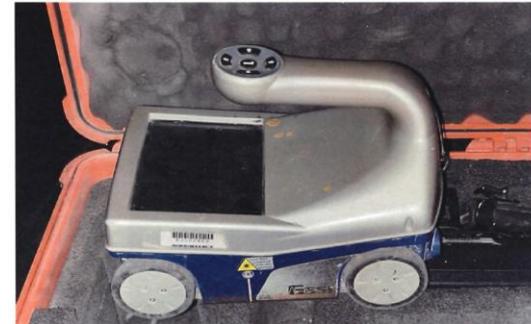
Photo 41

GSSI's Structure Scan Mini used to GPR scan the majority of slab-column connections on Levels 1 – 8.

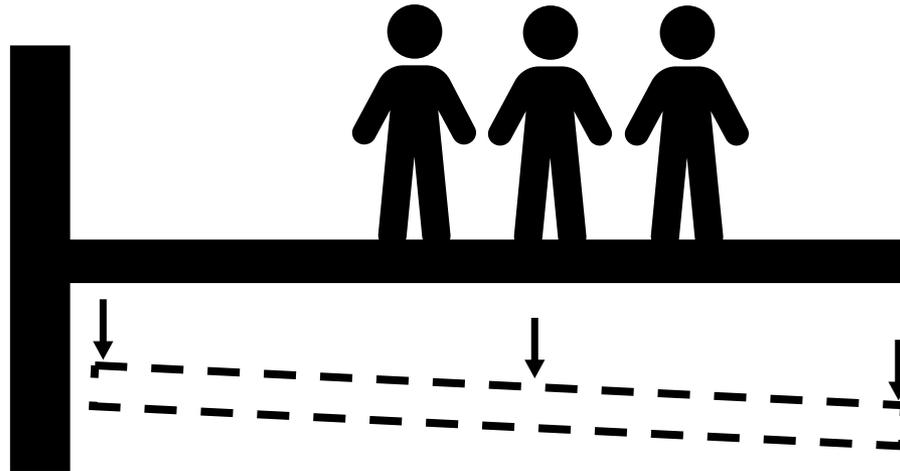
Punching Shear Explained

The slab needs to be strong enough to support the weight

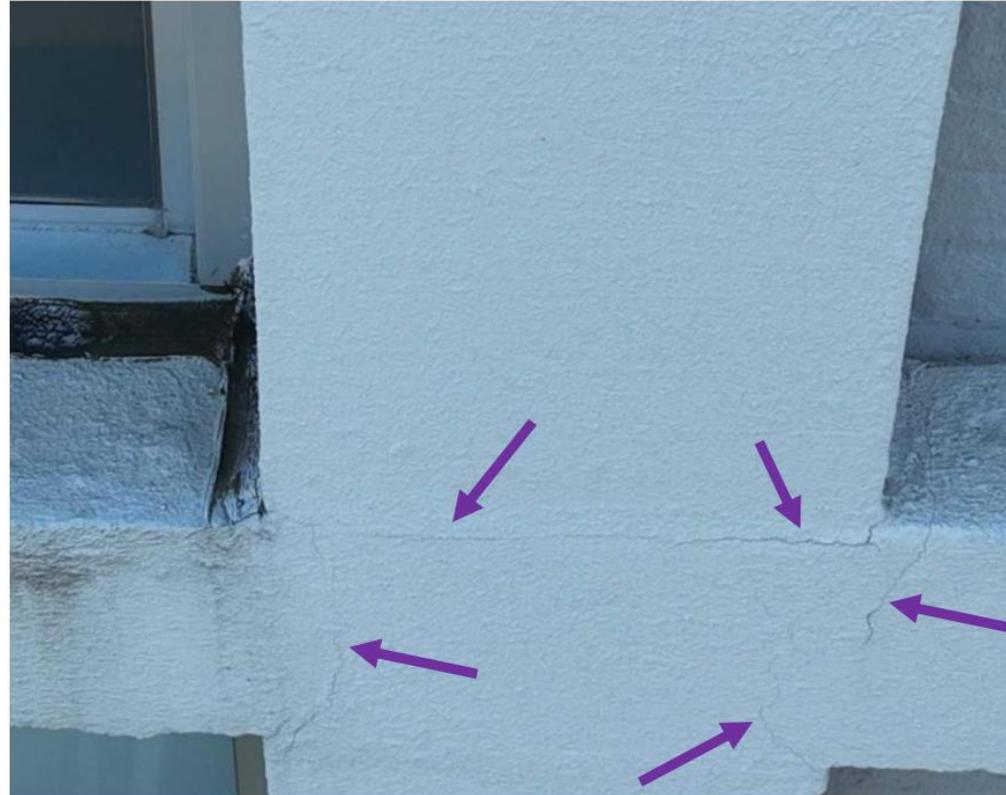
21 April 2025 Drone Survey, IMG#323

- Additional fencing installed to secure the site.
- Disconnecting utilities.
- City staff directed Condo Association to conduct a visual survey by **drone every 2 weeks** to identify changing conditions. Beginning this week.
